MEMORANDUM

DATE: July 21, 2017

SUBJECT: RECOMMENDATIONS CONCERNING THE CONSTRUCTION OF A
 FUMIGATION CHAMBER AT A PROCESSING FACILITY IN
 STANISLAUS COUNTY

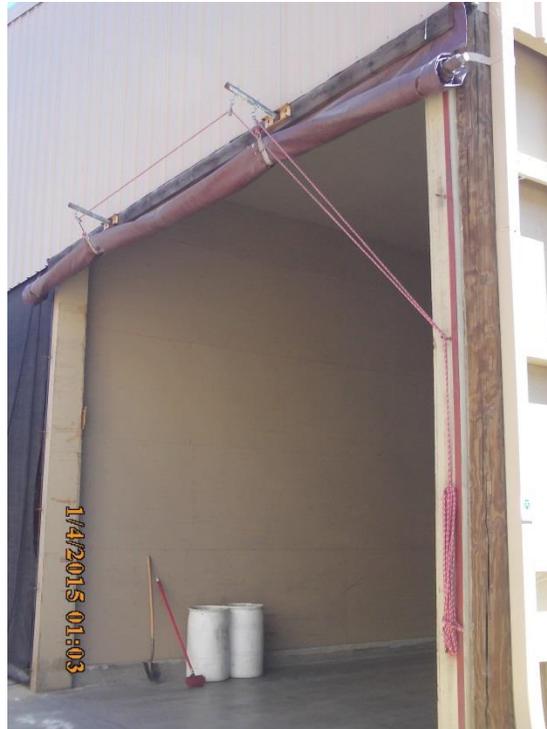
Figure Two: Tarp door on Chamber 2

Chamber 2 is a wooden structure that has a roll-down tarpaulin door (See Figure Two, note all photo date stamps are in error). It is classified as a “B1 Retention Tested/Standard Stack” chamber. During fumigation, the tarp is rolled down the face of the chamber, secured to the chamber with bolted-down wooden pressure bars and sealed on the floor with loose sand piled on the tarpaulin. It does not have an enclosed control room. It uses a recirculation fan system to keep the fumigant dispersed within the chamber. Aeration is performed by activating the aeration fan, which draws the tarp door inwards, then removing the sand and rolling up the tarp by about 1 foot to allow clean make-up air to flow into the chamber. A secondary louvered opening on the side is also opened to allow further make-up air in during aeration.

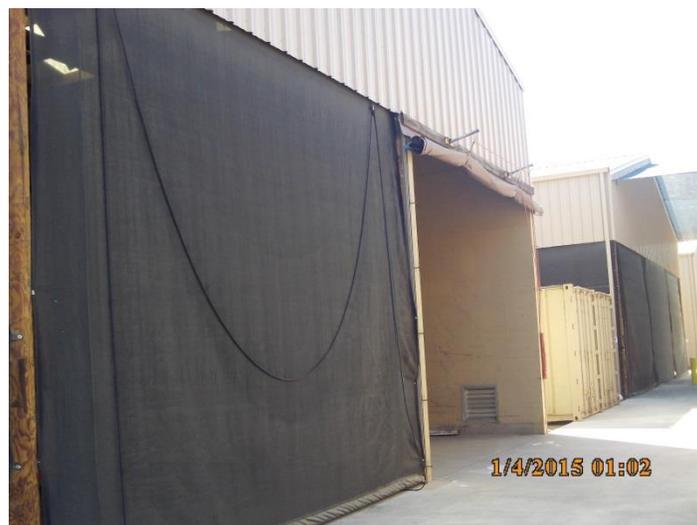
Figure Three: Pole barn screens

The chamber is situated in a pole barn which allows air circulation around the chamber. The chamber is not within an enclosed space as defined in the MBr Permit Conditions document. There is sufficient space around the site for adequate buffer zones for both the existing chamber and the proposed chamber. I would suggest posting warning signs at the edges of the respective fumigation and aeration buffer zones to provide a clear demarcation of the buffer zones. These can be A-frame signs, stand-alone sign posts, permanent painted markings on the surrounding blacktop, etc.

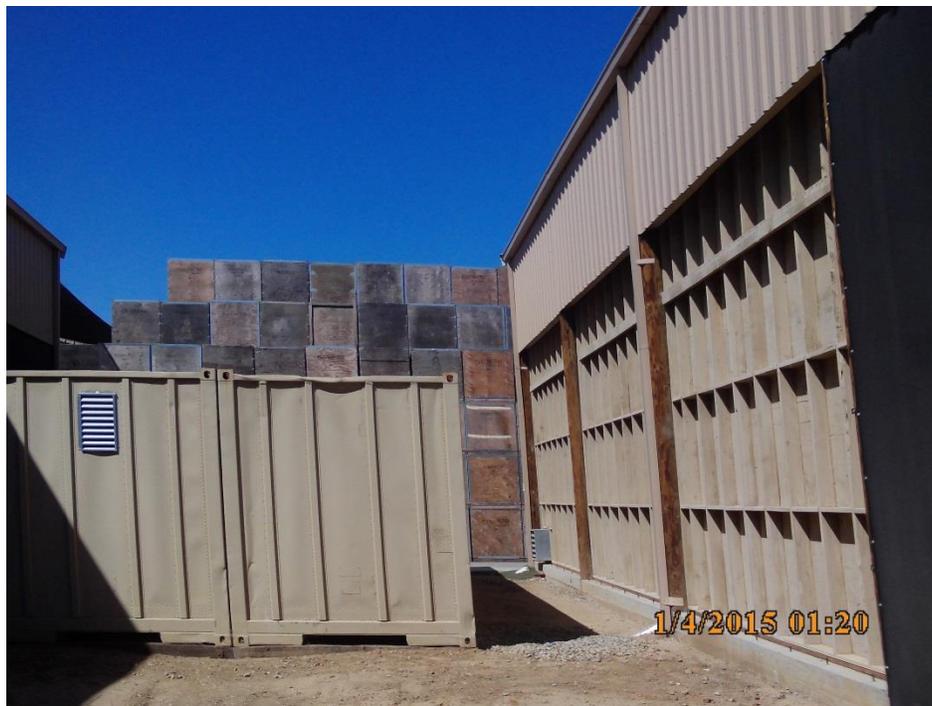
Figure Four: Passive vent on left for methyl bromide storage unit

On a related issue, the methyl bromide cylinder storage structure is an intermodal trailer. There were several methyl bromide cylinders in the unit. Though equipped with some basic passive venting (see Figure Four for vent on the rear of the unit) there did not appear to be any active mechanical venting system. In that the methyl bromide used for commodity fumigation is 100% methyl bromide with no chloropicrin warning agent, and that methyl bromide has no odor, I would advise at a bare minimum that the air within the intermodal be tested with a colorimetric detector (i.e. Draeger, Sensidyne, Kitagawa, etc.) before anyone is allowed to enter. The addition of an active mechanical ventilation system, to be activated early enough to allow 10 air exchanges within the intermodal before entry, would provide superior safety conditions for persons entering the intermodal.
